Proposals for Future Conservation Actions

Testing of Stone and Masonry Conservation Techniques and Materials

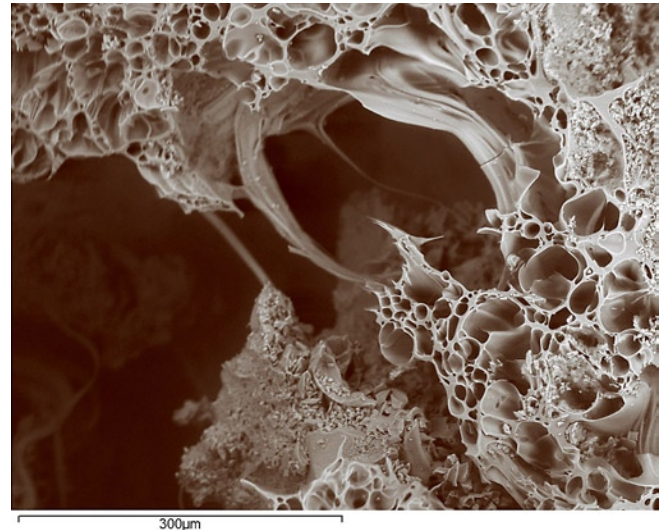
Several materials showed significant pozzolanicity: tierra blanca from El Salvador (a volcanic tephra with a high content of pumice), pumice from Guatemala, and a fired clay tile obtained from Copán Ruinas (**Fig. 98**). These materials should be considered if pozzolanic additives are required in the future—especially the pumice, if it continues to be available locally.

Figure 98 ESEM image of pumice from Guatemala, showing high-surface-area volcanic glass.

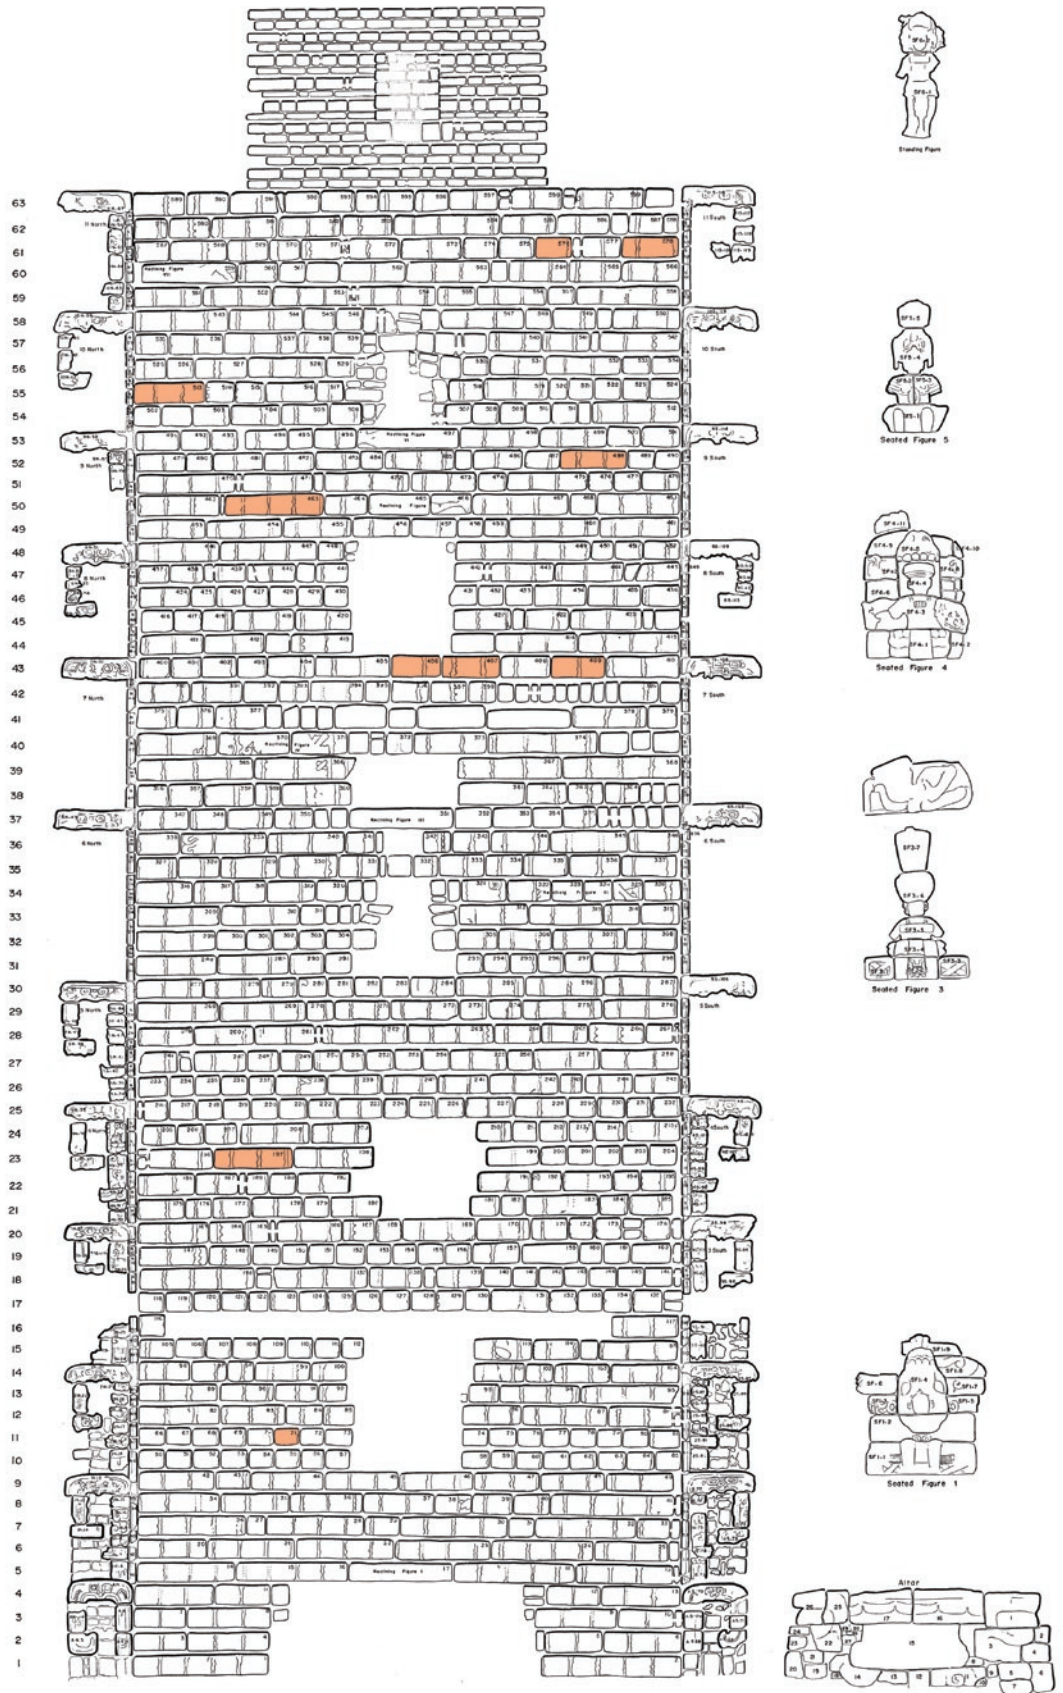
Figure 104 shows the location of the treatment trial blocks on the Stairway.

Figure 104 Locations of the treatment trial blocks (in orange) on the Hieroglyphic Stairway.

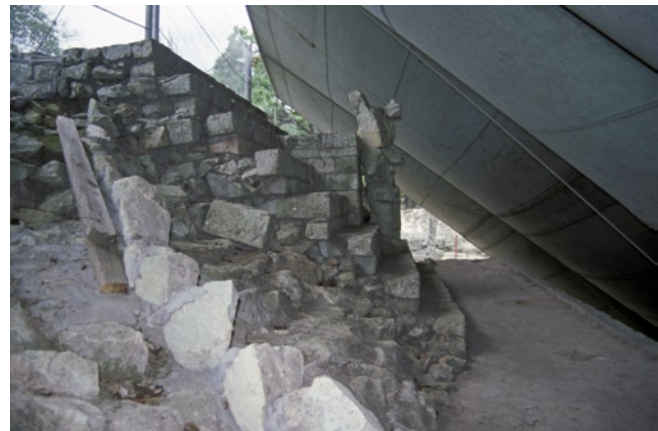
Since the shelter was first installed in 1985, modifications to it have been made to improve its protective function. Primarily, the length of the tarpaulin has been extended so that it covers more of the upper part of the pyramid (**Figs. 126, 127a, b**), and as a consequence, rainwater no longer collects above the Stairway. During this project, modifications to the shelter have already been proposed informally, and some have been carried out, such as improvements to the lateral anchoring of the tarpaulin so that it remains more taut and less prone to tear in high winds (**Figs. 128, 129**). The following additional modifications could be employed to improve the current performance of the shelter:

Figure 126 The top of the Stairway pyramid. The tarpaulin extends beyond the platform above the Stairway.

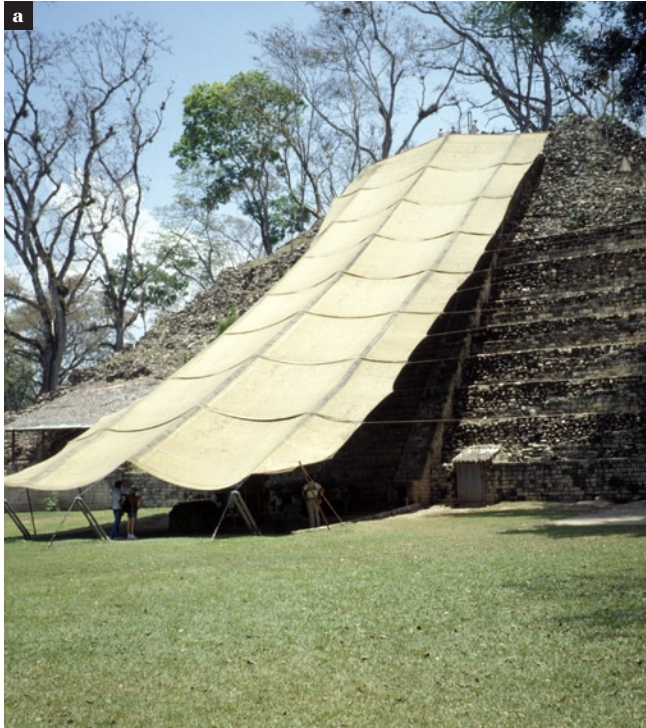
Figures 127a and b The shelter of the Hieroglyphic Stairway in 1992, with coverage that stops short of the top of the pyramid (a); a replacement tarpaulin, in place in 2001, offers greater coverage of the top of the pyramid (b).

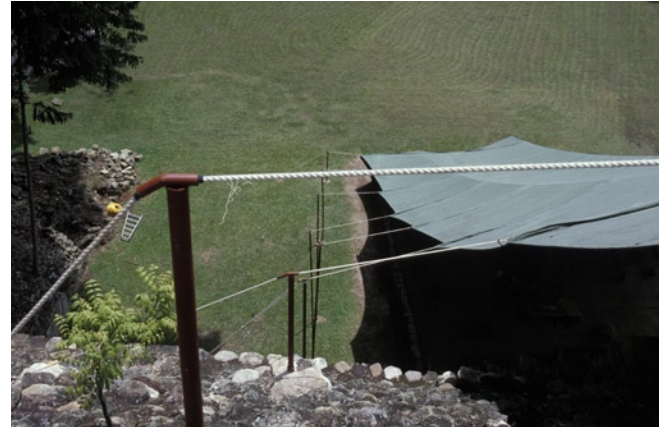
Figure 129 Shelter in 2005, with a modified lateral support system that keeps the tarpaulin taut.
